# Forensic Engineering Experience with Purported Electric Shocks

By Roger L. Boyell, P.E. (NAFE 696F)

This paper summarizes the author's investigations into 12 different complaints of electrical contact causing bodily injury or death. Numerous photographs are provided for clarification. The 12 scenarios range from **obvious** to **unforeseeable**, and from **expected** to **impossible**.

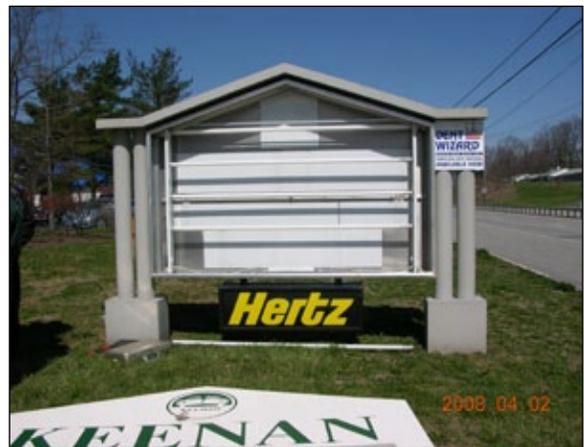
As illustrated by Figure 1 the electrician removed the translucent letter board and diagnosed the failure as due to a defective fluorescent lamp ballast, shown in Figure 2. Being familiar with the facility from previous visits, he turned off the circuit breaker for the building's "Outside Lights" and began to change out the ballast.

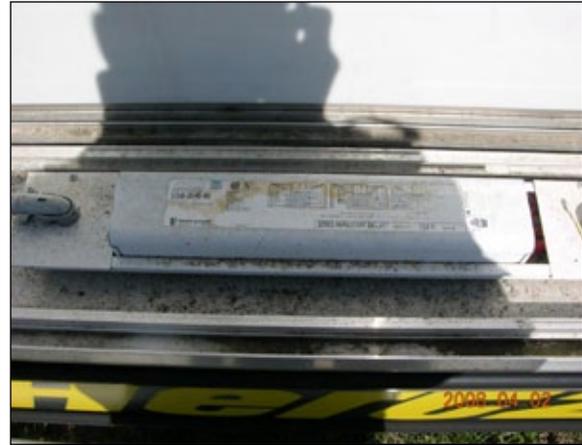
Figure 3

The detailed wiring diagram printed on the ballast can be seen in Figure 3. The primary winding accepts 120 V ac (volts, alternating current). Multiple taps on the secondary are used to feed individual fluorescent lamps with high voltage to strike, then limited current to remain illuminated. With no load the secondary winding develops 1,500 V center-tapped to ground.

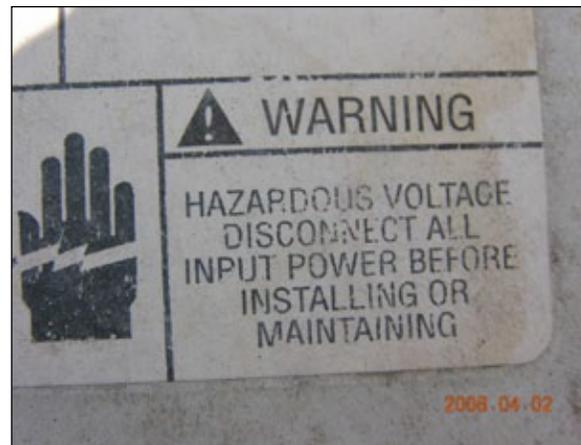
Figure 4

We do not know whether the electrician read the warning of Figure 4, also printed on the ballast. If he had used a meter or voltage probe he would have recognized that he was working, unintentionally, on a hot circuit. Later it was found that the circuit breaker he should have turned off was the one labeled "Outside Sign".

In addition, his procedure of connecting the primary wires before connecting the high-voltage secondary was logically flawed. The flaw was fatal in every sense of the word.

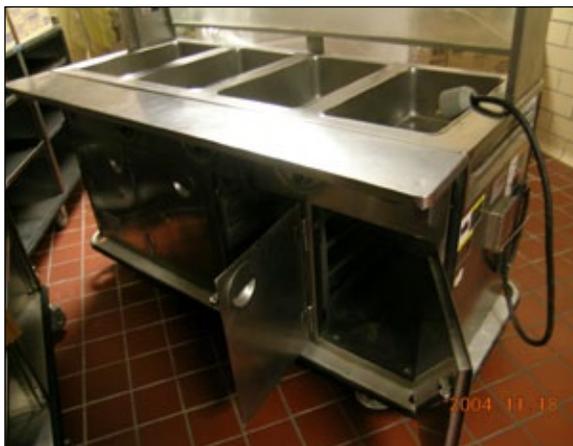
A restaurant worker complained of receiving a disabling electric shock from wires he said were exposed under a steam table. As shown in Figure 5 the steam table had a heavy cord and plug, and it drew 20 A (amperes) from a 240 V circuit, making it a good candidate for an accusation of shock.

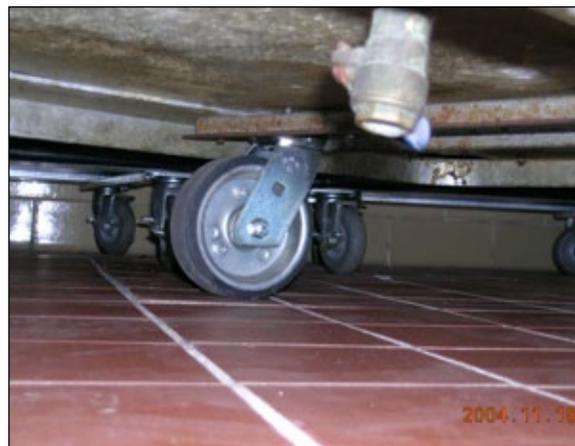
And so it was that a legal claim was filed. The steam table was placed in storage until an engineer could investigate the complaint. Then the underside of the steam table shown in Figure 6 was found to be all metal with nothing exposed except a drain cock which itself was metal. No wires were present.

All surfaces were electrically connected and solidly grounded through the cord and plug. No leakage current flowed from steam table frame to earth ground. The receptacle in use at the time of the incident exhibited a solid ground.

Shock to the client from the steam table as described was thus impossible. When the lawyers were confronted with these findings, the claim was abandoned.

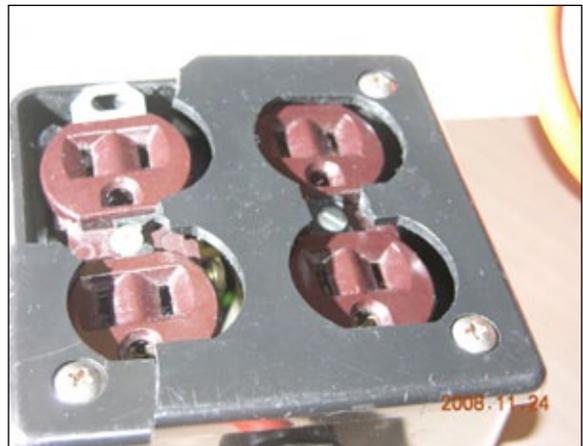
After lengthy legal process another party was compelled to produce the extension cord into which, it was learned, the machine was being plugged at the time of the incident. Figure 7 shows the portable outlet box whose plastic cover plate was fractured and whose receptacle yokes were unsecured. Its condition explains why the party was unwilling to provide it for examination.

Reconstruction of the incident (but not under power) showed that plugging in any appliance cord set would dislocate the loose receptacles. When finally opened for examination the box showed electrical scars seen in Figure 8, where the hot side of one receptacle had contacted the neutral side of the other receptacle.

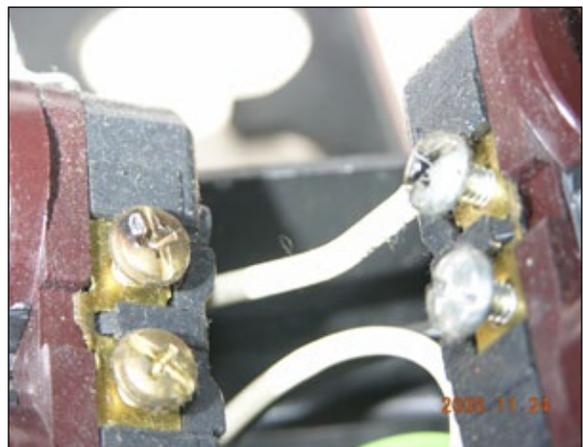
Figure 8

The electric arc which occurred in the damaged box could certainly have given rise to the claimed shock/flash/burn injury. The case against the manufacturer of the baggage-scanning X-ray machine was dismissed, and the party supplying the extension cord became the defendant. A confidential settlement was rapidly reached.

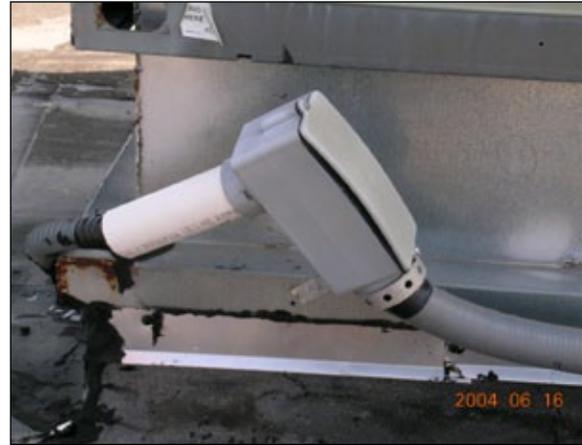
The electrical junction box shown in Figure 9 illustrates many National Electrical Code violations: stressed and overstuffed connector body, L-body should have been straight type, unapproved retaining clamp, PVC pipe instead of a listed fitting for the armored cable.

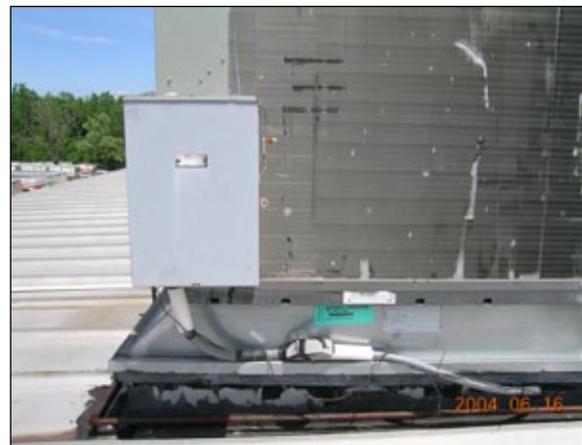
Figure 10

An air conditioning technician observed these violations while checking the rooftop air conditioning unit shown in Figure 10. He claimed that the shock and burn he received from an electrically energized surface of the unit disabled him such that he couldn't do any more air conditioning work.

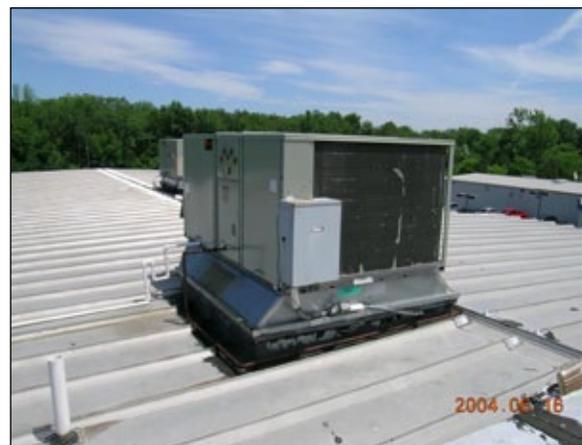
Careful engineering examination of the entire unit shown in Figure 11 revealed no electrical hazard. Despite its appearance no conductors were accidentally exposed or shorted, and the junction box afforded no opportunity for insertion of even a child's finger.

However, the metal roof itself was indeed hot. The examination was conducted at around noon and on a date close to the Summer Solstice. The shadow of the pipe in the foreground of Figure 11 shows that the Sun was essentially overhead. The real danger to workers on that corrugated metal deck was found to be the baking temperature of the roofing material, which was hot enough to burn foot soles even through leather shoes.

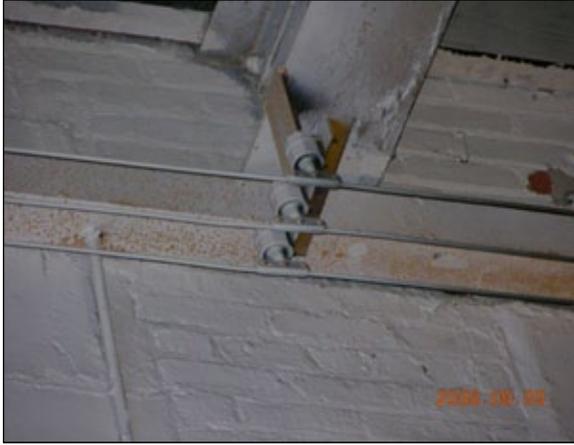
**Figure 12**

The wires shown in Figure 12 ran across the 5-meter-high ceiling of a dingy warehouse, serving an overhead crane which had not been operational for many years. The old crane was simply abandoned, off in a corner of the bay, because its scrap value would not have covered the cost of removal.

A worker installing security cameras used a 3-meter-high forklift platform to boost himself up toward the ceiling. Losing his balance he grabbed the wires for support. His hand made contact with two of the wires, and an arc flash vaporized much of his hand before he fell to the floor.

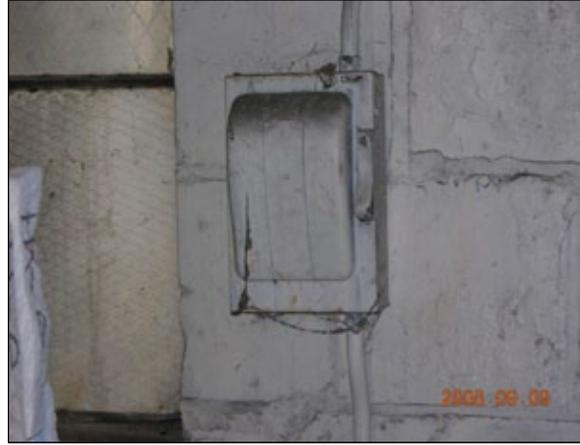
**Figure 13**

The investigators, crawling through a crumbling and dusty section of the warehouse, found the cobweb-draped disconnect switch shown in Figure 13. Sure enough, it served the abandoned crane wires with 460-volt 3-phase power, and its rocker switch was still in the ON position. Liability of the warehouse owner to an employee of an outside contractor was the subject of the subsequent litigation.

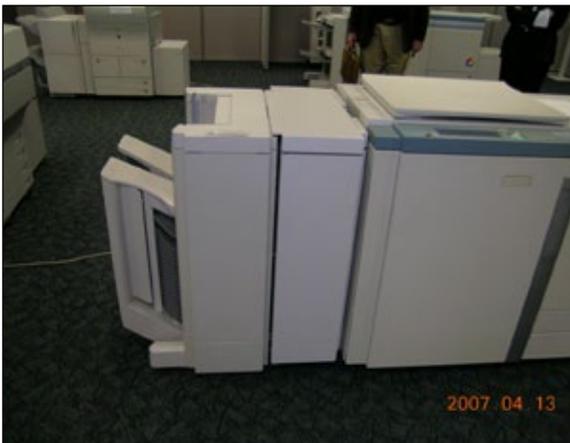
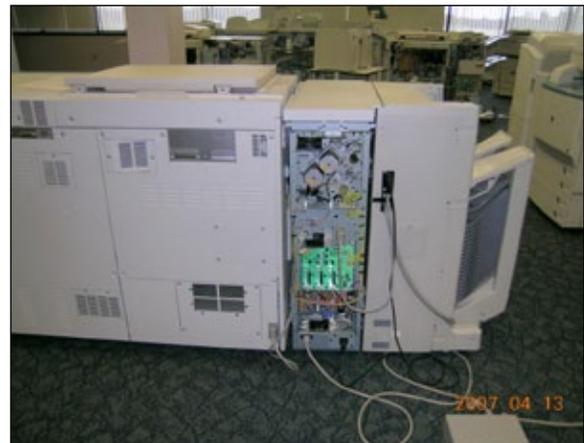
As shown in Figures 14 and 15 the basic machine was coupled with a ‘buffer’ and a ‘sorter’ as separate chasses. One theory of the incident was that the just-ejected paper carried a sufficient static electric voltage to spark across the operator’s hand to the grounded machine, although the injuriousness of the minute current from a static discharge was questioned.

Another theory was that the separate chasses, being simply pushed in to position, were not electrically bonded. Somehow the potential of one chassis was raised 120 V ac with respect to another, across which the operator’s hand was moved. Of course a third theory was that the incident didn’t occur.

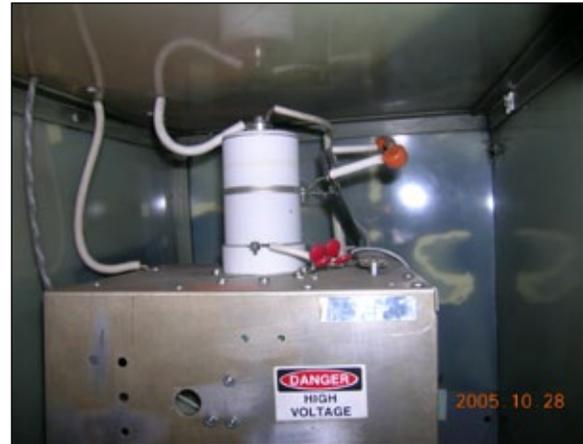
Figure 16

A well-known manufacturer of high-voltage power supplies had a subsidiary whose specialty was serving the high-power laser industry. They produced a unit which held 15,000 V dc to tight tolerances for regulation and ripple even when subjected to loads up to 300 mA (milliamperes). To test such a laser-driving power supply they built fixtures of the type shown in Figure 16.

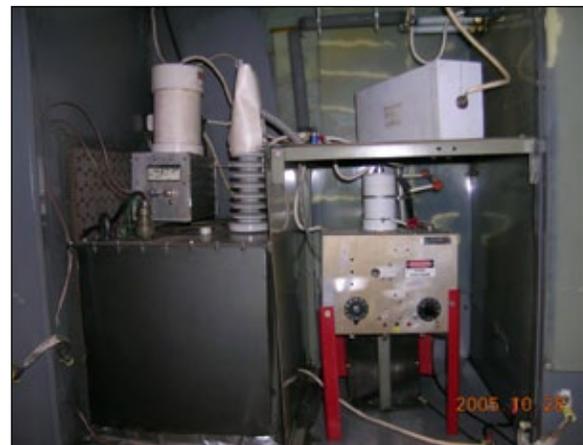
The fixture includes a switch which slams a 50,000-ohm, 5,000-watt heating element across the otherwise unloaded 15 kV supply, while instruments track its performance. Figure 17 shows some of the other components associated with the test fixture – obviously not a commercially sold device.

No one in the company had informed the worker that the component at the upper right of Figure 17 was a capacitor. Its markings are in the close-up of Figure 18. (It is ironic that the capacitor is labeled to contain no harmful chemicals. It bears no warning about harmful electricity.) Although the worker had attended safety briefings, he had never been given a shorting bar. He didn't know the capacitor would retain any of the 15 kV charge.

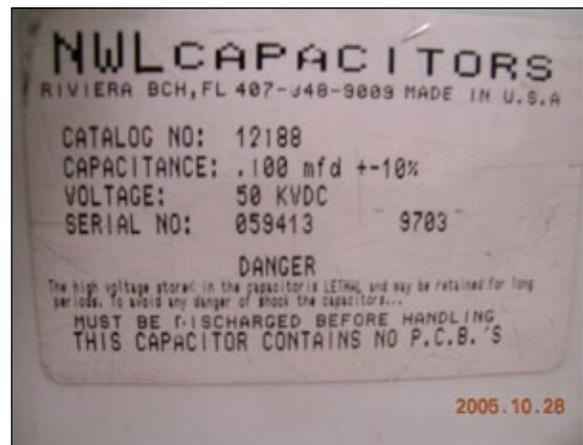
Figure 18

Based on the time constant of a leaky circuit whose capacitance is 0.1 microfarad into the bleeder resistor of 1,000 megohms we estimate the worker contacted 5,000 volts. The company received a citation from the Occupational Health and Safety Administration and revised its practices accordingly. The estate of the worker was unsuccessful in their lawsuit against the company for gross negligence.

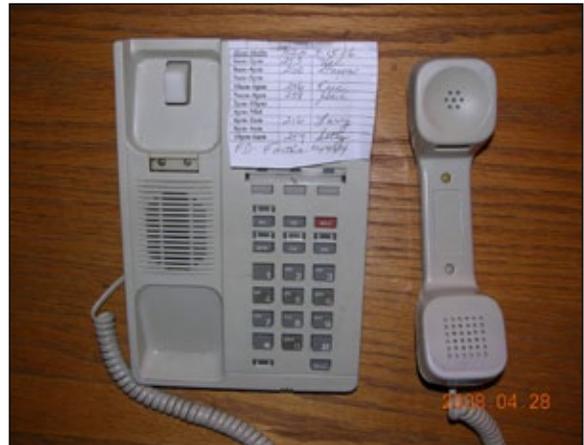
**Figure 19**

Claims of electric shock to a subject may be difficult to verify. The user of the telephone set illustrated in Figure 19 suffered damage to her ear and head, allegedly an electric shock from the handset. Investigation of crossed power lines, lightning strikes, and dielectric withstand of the plastic all refuted the claim of electric shock.

Perseverance by the claimant's lawyer raised the possibility of acoustic shock. An intermittent connection was found to initiate the boot-up sequence of a microprocessor in the base of the telephone while the earpiece remained unmuted. The unexpected static may have been a blast in the ear of the unalerted user.

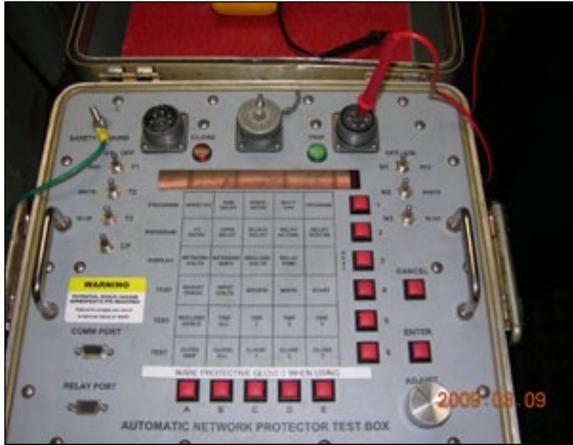
Figure 20

The user is instructed to apply the safety ground clamp a to a reliable earth ground, before connecting any test cables to the multipin connectors. Do not assume a ‘neutral’ conductor is at ground potential. Maintain the “Safety Ground” wire, shown at the upper left of Figure 20, connected to a securely grounded conductor such as the unpainted frame of an electric switchboard. Use the clamp shown in Figure 21, all through any test procedure.

Under questioning the worker admitted that he had not secured the clamp to a known earth ground but simply let it pinch a convenient nearby surface to hold the wire out of the way. Having disregarded formal instructions, his shocking claim was dismissed.

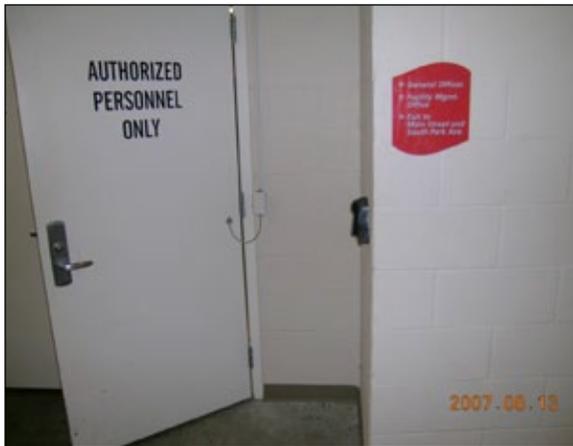
**Figure 22**

A completely disabling electric shock was reported by a victim who held the handle of the door shown in Figure 22, and a witness testified that the victim exclaimed he was hurt when he pulled on the handle.

It was a metal door with metal hinges hung on a metal frame inside a concrete building. Everything was solidly interconnected and grounded. Wires for the card reader, exit pushbar (The pushbar was on the opposite side of the door.), and door strike are all low voltage (12 V dc, 24 V ac), and all were in metal conduit as shown in Figure 23. Apparently the victim had been hauling something with his other hand at the time of the alleged shock from the door. Further, other people used the same door on the same occasion, and no else reported an injury from it.

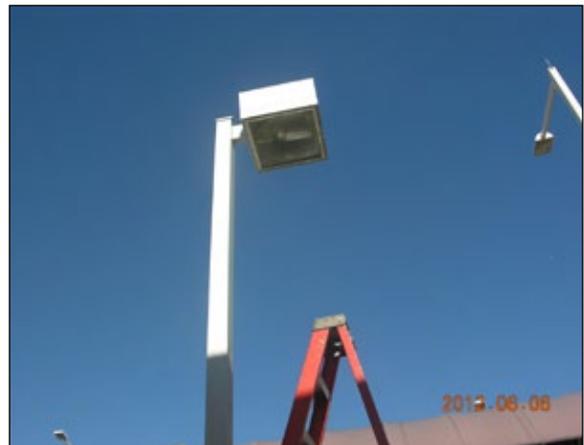
**Figure 24**

A worker for a condominium had erected a 4-meter A-frame ladder in order to service a 5-meter pole light fixture in the parking lot. Figure 24 shows the fixture, and Figure 25 is the view from beneath the fixture when two lens-holding fasteners are removed and the lens has swung out of the way. The 250-watt metal-halide lamp has been unscrewed from the mogul-size socket.

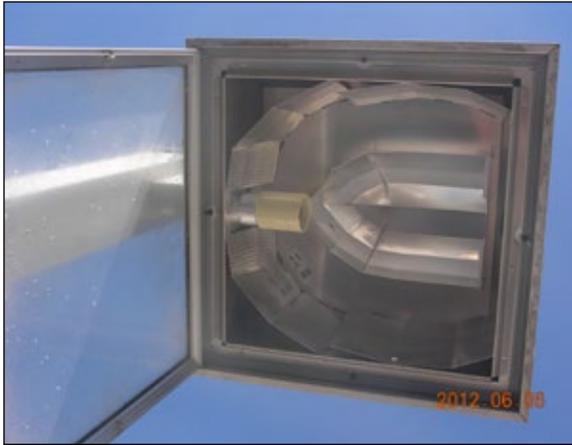
**Figure 25**

Examination and testing of the fixture, the pole, and the wiring thereto showed that everything touchable was at neutral/ground potential and thus could not cause a shock. The electrically energized center pin was deep inside the lamp socket and could not be touched by a worker while he was holding the lamp.

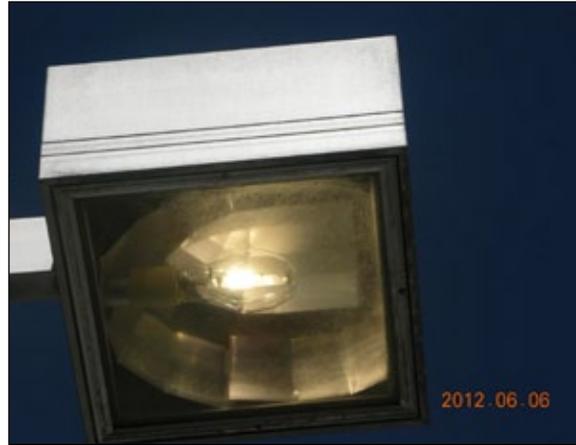
**Figure 26**

Further, simply screwing the new lamp into the socket effected normal operation of the fixture, as shown in Figure 26. The examining engineer thus concluded that no physical evidence existed to support the shock part of the worker's claim.

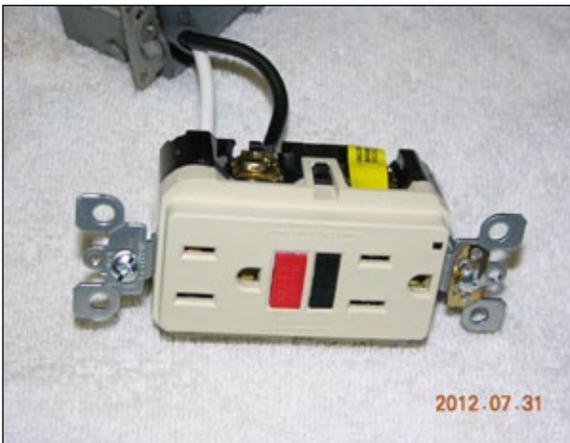
Figure 27

Expert examination determined that the drain machine was properly wired, and its frame was properly grounded through the third pin of its attachment plug. An inspector's outlet tester had revealed no issue with the GFCI receptacle, which was of the type shown in Figure 27. The electrically hot (black) and neutral (white) conductors were found to be attached to their proper terminals.

There was no ground conductor. The house wiring was old and did not carry a ground to the location of this receptacle. In this event the proper installation would be to label the receptacle “No Equipment Ground” and let the GFCI capability protect the appliance user as it is designed to do.

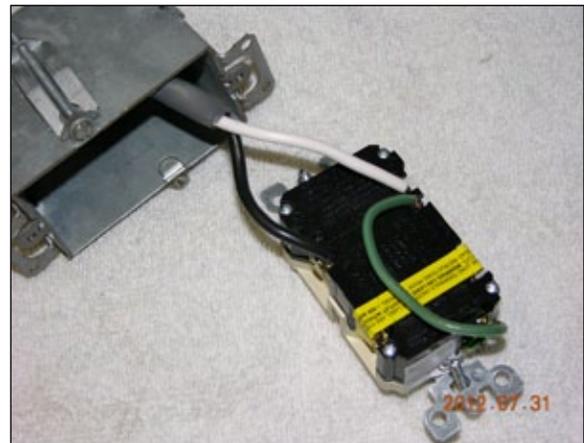
Unfortunately the receptacle installer (obviously an amateur) was unhappy with leaving the ground terminal unconnected, so he ran a jumper from it to the neutral terminal, shown as the green wire in Figure 28 – wrong but still not hazardous to the plumber.

The presence of the jumper, however, exposed another defect in the house wiring. Somewhere upstream of the receptacle at issue the polarity had been reversed. The black wire was actually the neutral, and the white wire was the hot conductor. The unwarranted jumper therefore caused the third pin of the GFCI receptacle, intended as a safety ground, to carry full line voltage.

In turn any appliance whose third pin on its attachment plug was wired as a safety ground for its frame, would exhibit a potential of 120 V ac on any exposed surface when merely plugged in to that defectively wired receptacle. Accordingly the drain machine was cleared, as was the clogged drain itself. Legal action against the homeowner is contemplated.
